**SAS Superstructure**

Location: 04-SF-80-13.2 / 13.9

Daily Diary Report by Bid Item

Diary #: 364 Const Calendar Day: 695 Date: 04-Aug-2011 Thursday

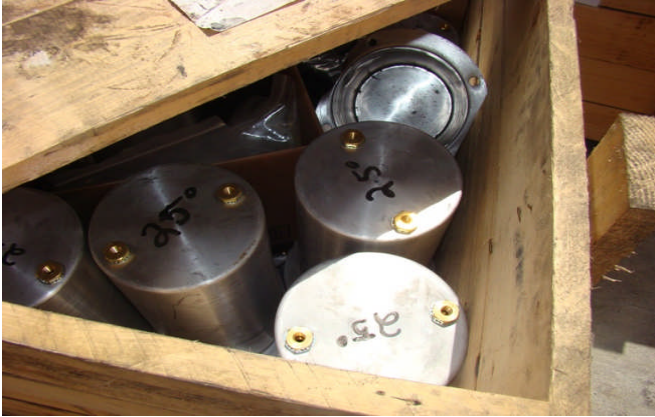
Grease caps for the exposed ends of the Macalloy rods.

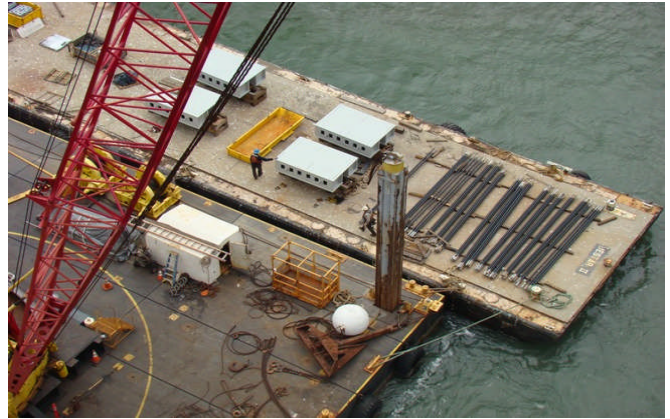
Anchor rods for the Shear Keys and Bearings and the temporary bearings on the barge mobilized for placement on and in the E2 cap beam.

- Reviewed TY-Lin's response to RFI# 2518R00: E2 Shear Key Anchor Rod Grouting - Modified Placement Procedure.
- See Lalit's diary for details on the operation, equipment, and labor of the Shear Key and Bearing concrete prep work, anchor rod support frame installation, temporary bearing placement, and anchor rod placement at the E2 cap beam.

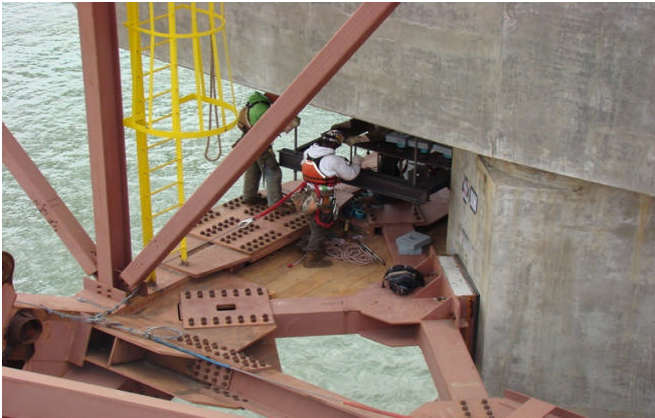
ABF ironworkers installing the bearing plates for the B4 bearing on the anchor rod support frame on the bottom side of the E2 cap beam.

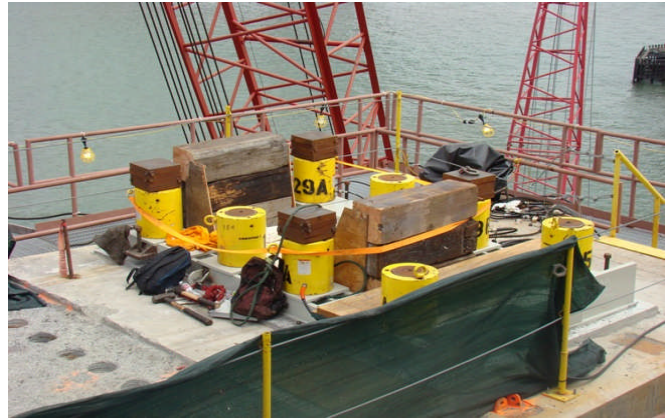
Temporary bearing base jacks and timber set up in preparation for the placement of the top half of the temporary bearing.
